Independent Test for Durability and Functionality

Safety Seal Tubeless Tire Repairs

Submitted by : North Shore Laboratories

Safety Seal Proven Safe & Effective for the Life of the Tire

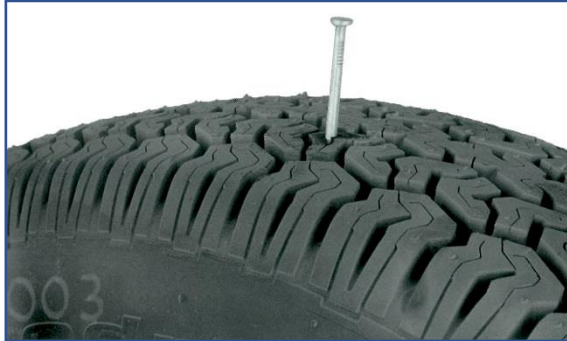
The Puncture

- Four BF Goodrich P205/75 R15 XLM H/T steel belted radials
- Four punctures, one per tire, using a 3/16 inch common nail.
- Tire driven 50 miles with nails in place to simulate real world conditions.

Four (4) new BF Goodrich P205/75 R15 XLM H/T tires were punctured using 3/16" common nails which were left in the tire. The tires were subjected to a pre-test holographic analysis to confirm structural integrity. Tire were then placed on a 1989 Chevrolet Astrovan, inflated to 35 psi and driven for 50 miles with the nails still in them to better simulate a real-world puncture. The tires were then taken to an independent repair facility where they were repaired using Safety Seal repairs following the manufacturer's instructions. The tires were then driven on until treadwear reached the legal limit (when the treadwear indicators were exposed), **a distance of 41,351 miles.**

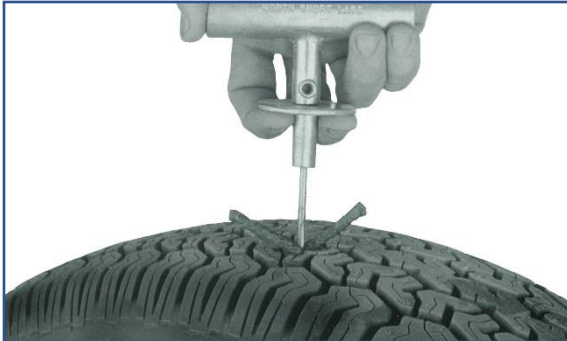
The Repair

- Tires repaired using Safety Seal tubeless tire repairs.
- Tires inflated to 35 psi and delivered to test facility.

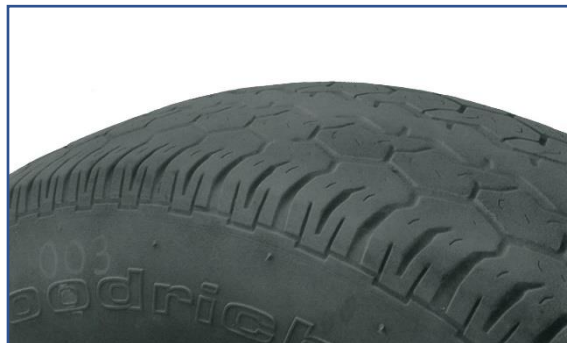
The Results

- After 41,351 miles the tread has reached the end of its useable life.
- The Safety Seal repairs and tires are inspected three ways:

X-Ray - Holography - Visual

- 1) Physical inspection showed **no air loss** during testing.
- 2) Holographic analysis showed **no ply separation or other damage** at or near the repairs.
- 3) X-ray analysis showed **no wire cord corrosion, deterioration, distortion or rusting.**

Final Analysis after 41,000 Miles				
	Tire #1	Tire #2	Tire #3	Tire #4
X-Ray Inspection	Pass	Pass	Pass	Pass
Holographic Inspection	Pass	Pass	Pass	Pass
Visual Inspection	Pass	Pass	Pass	Pass
